TRAC Vegetation Management

GEOTECHNICAL SERVICES

STOMEFERRY ROCK WORKS

WESTERN ROUTE CUTTINGS STABILISATION FRAMEWORK

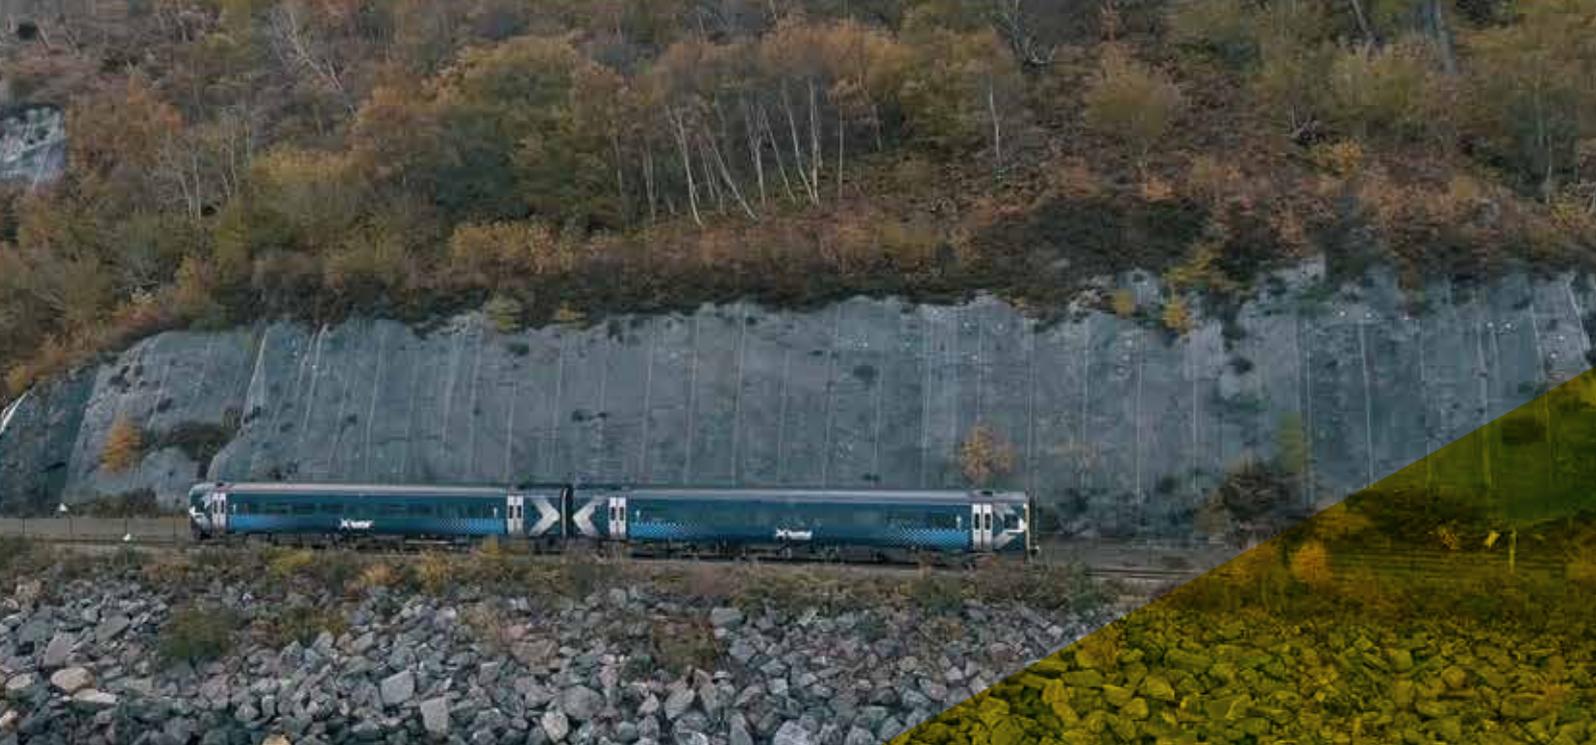
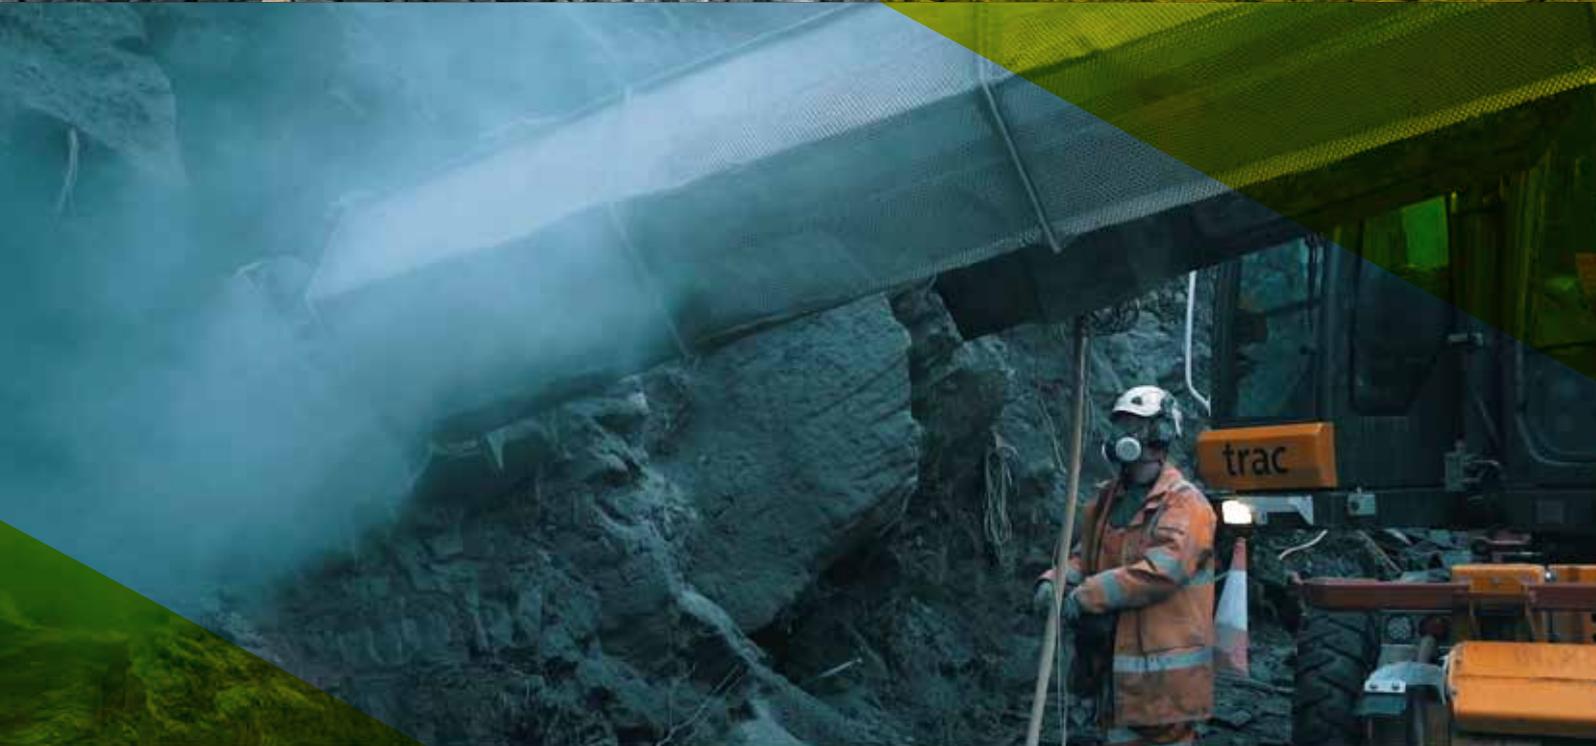
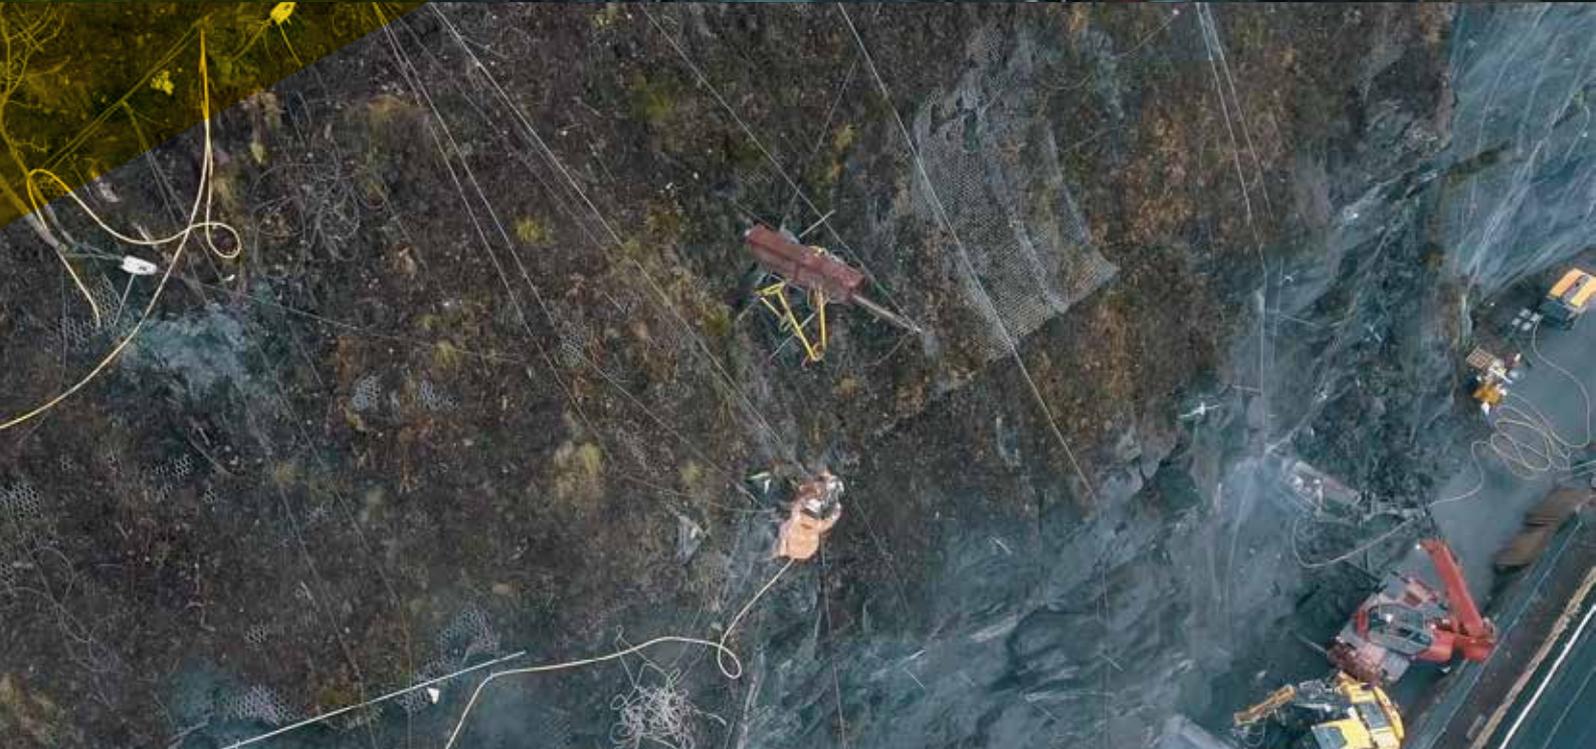
Utilising a combination of specialist geotechnical knowledge, rope access techniques, plant and equipment, more than 2800m² of vegetation was cleared, 400 tonnes of material scaled from the face, and over 2400 metres drilled for the 350 anchors installed.

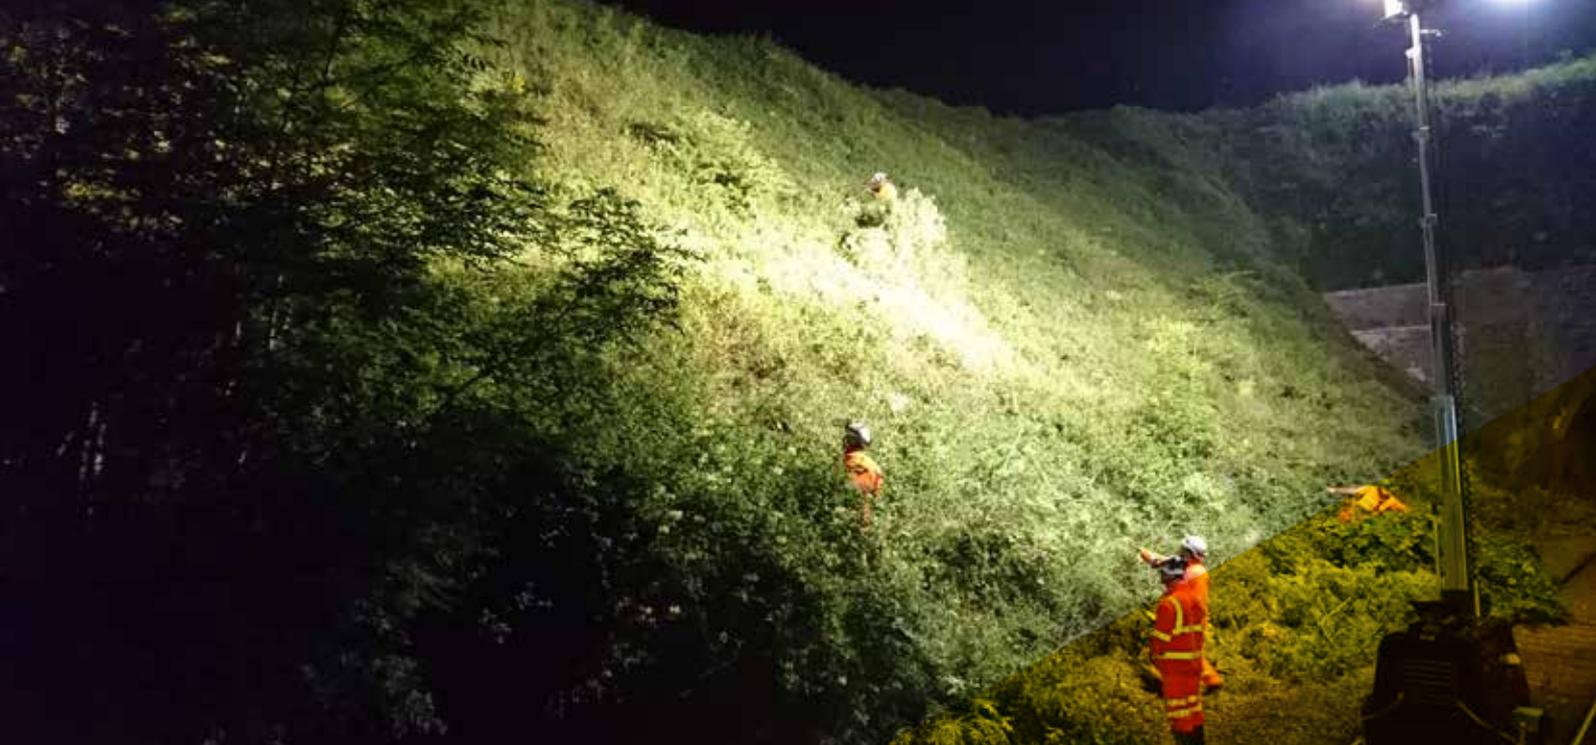
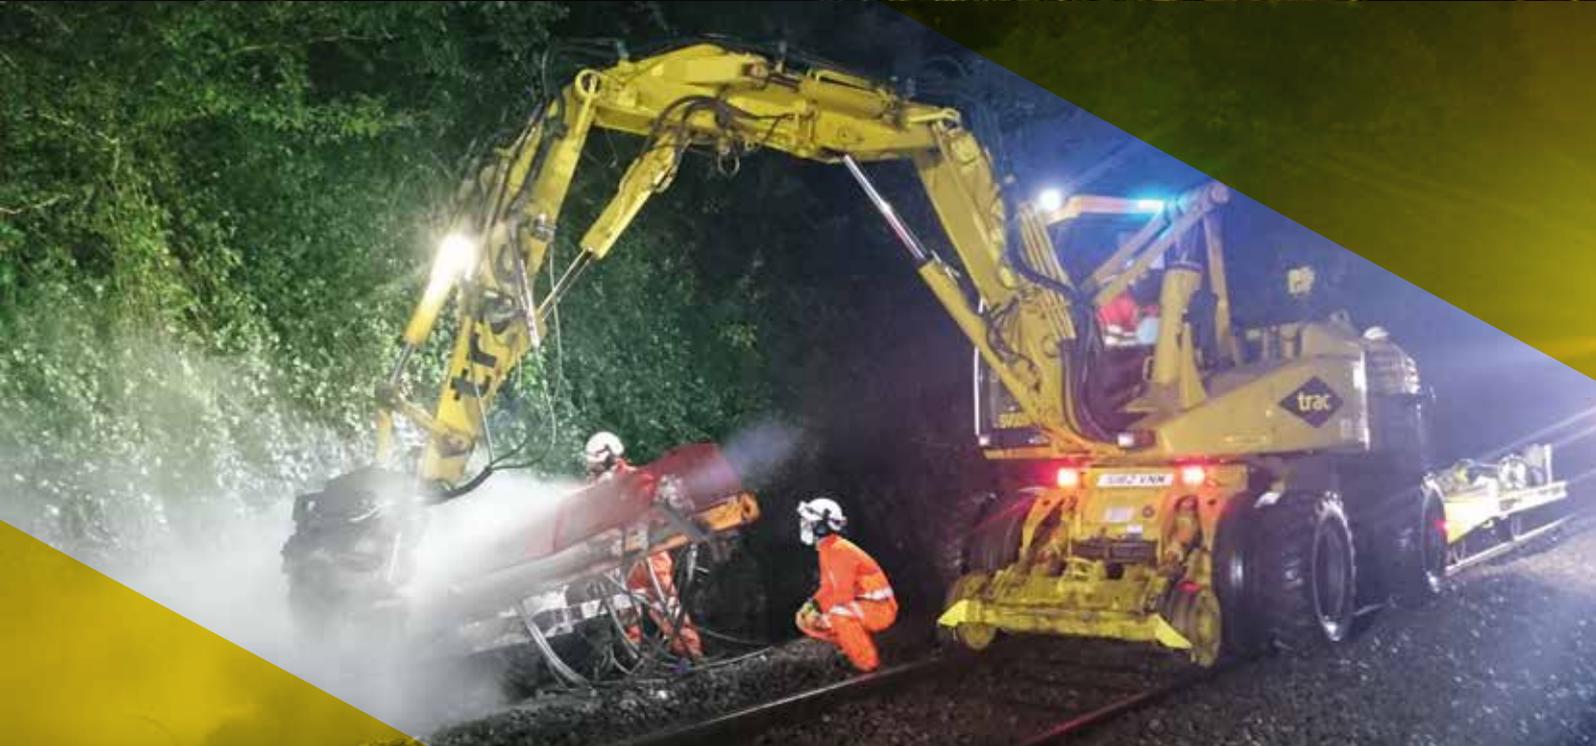
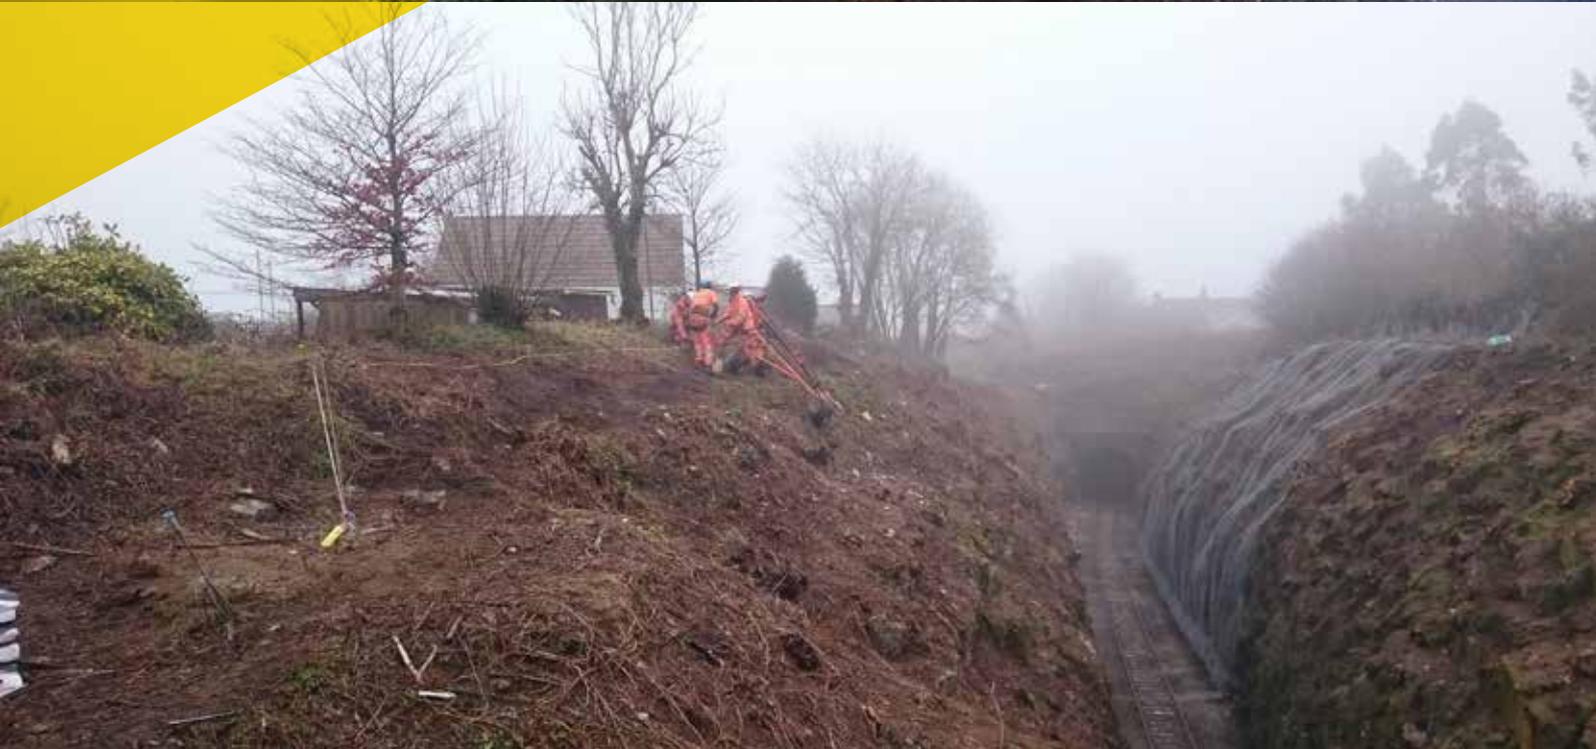
Over 50,000m² of vegetation was cleared and more than 6000m² of netting installed during the project lifecycle, utilising a combination of laboured and mechanical methods to deliver this scope of works in some of the most inaccessible locations of the UK rail infrastructure.

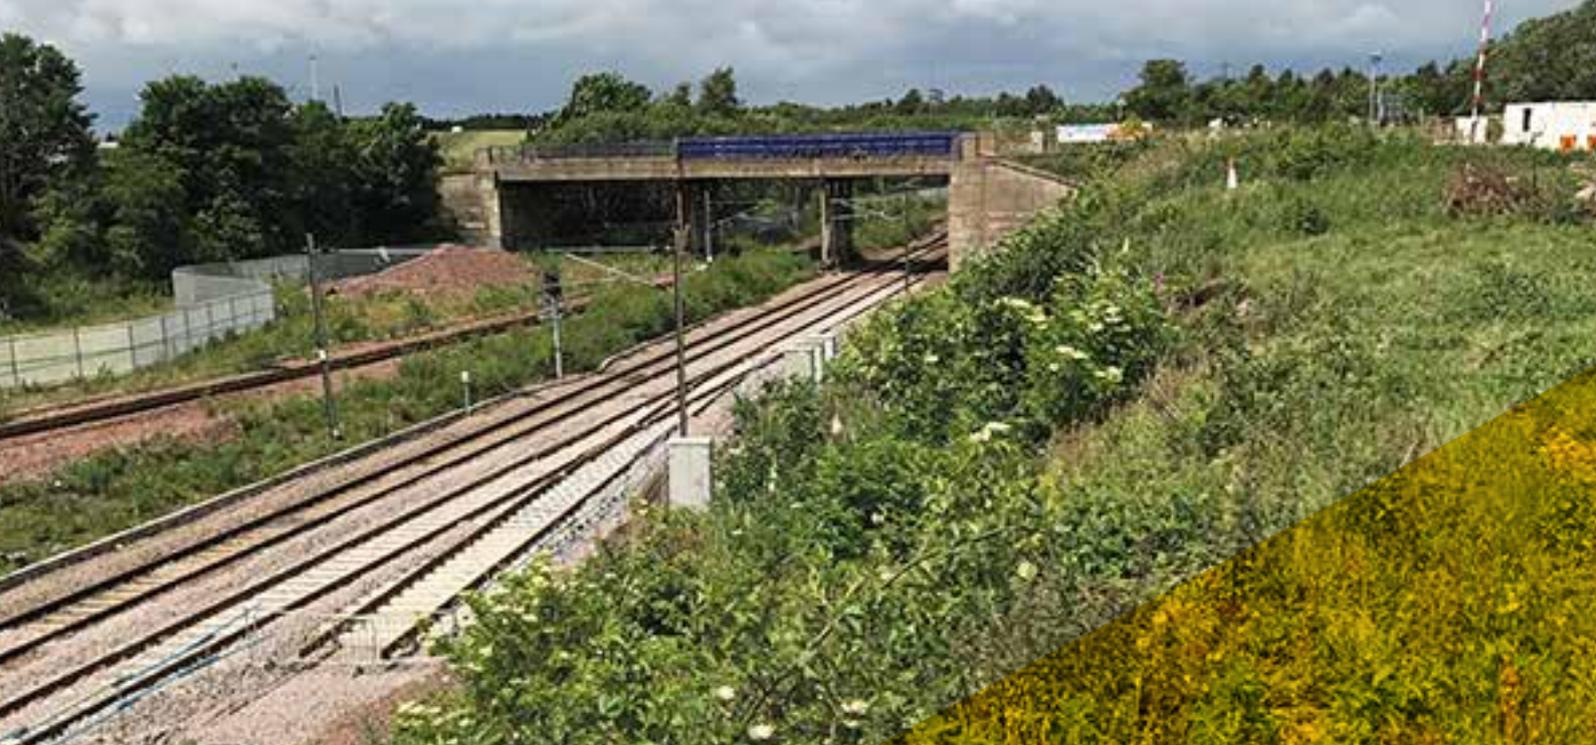
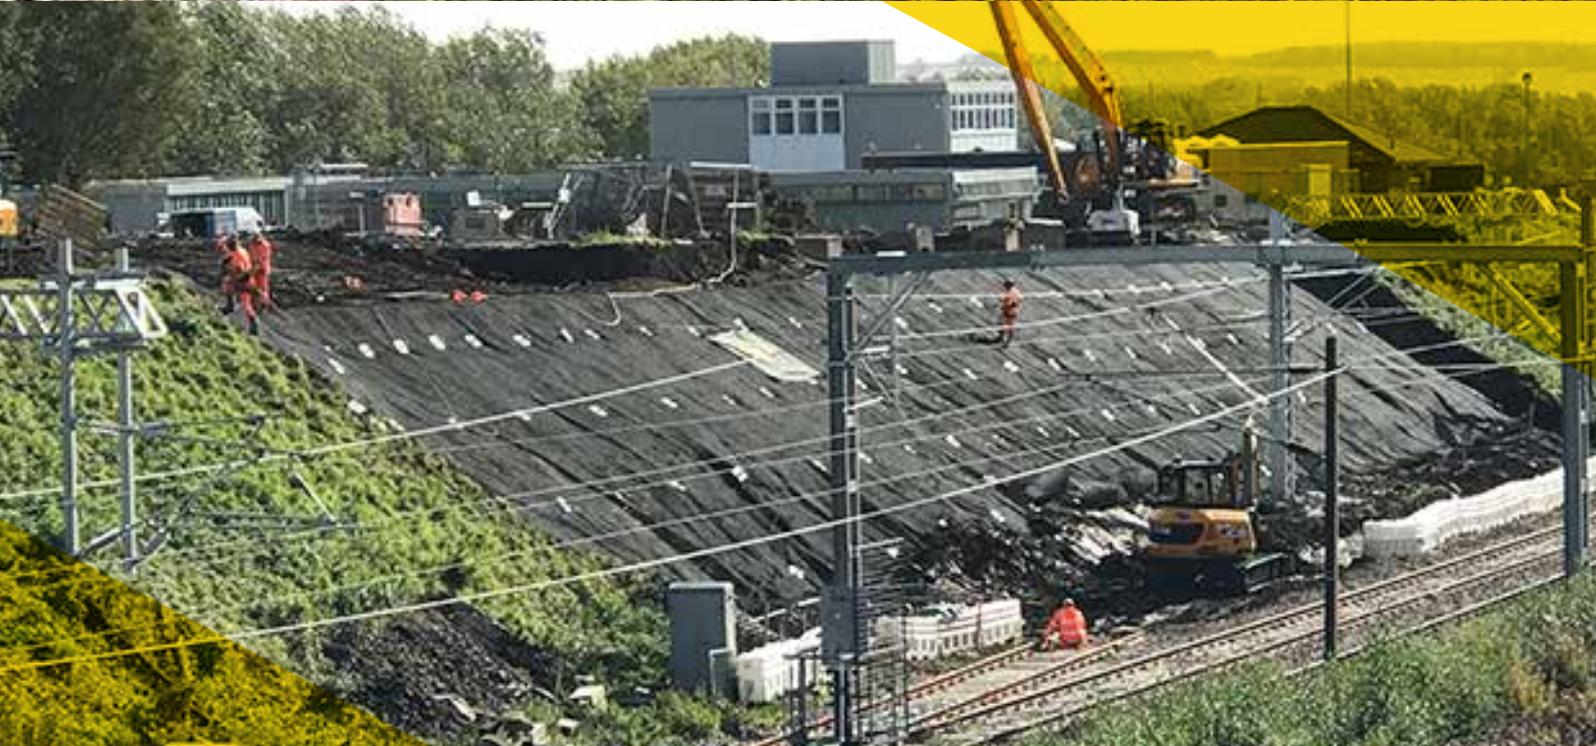
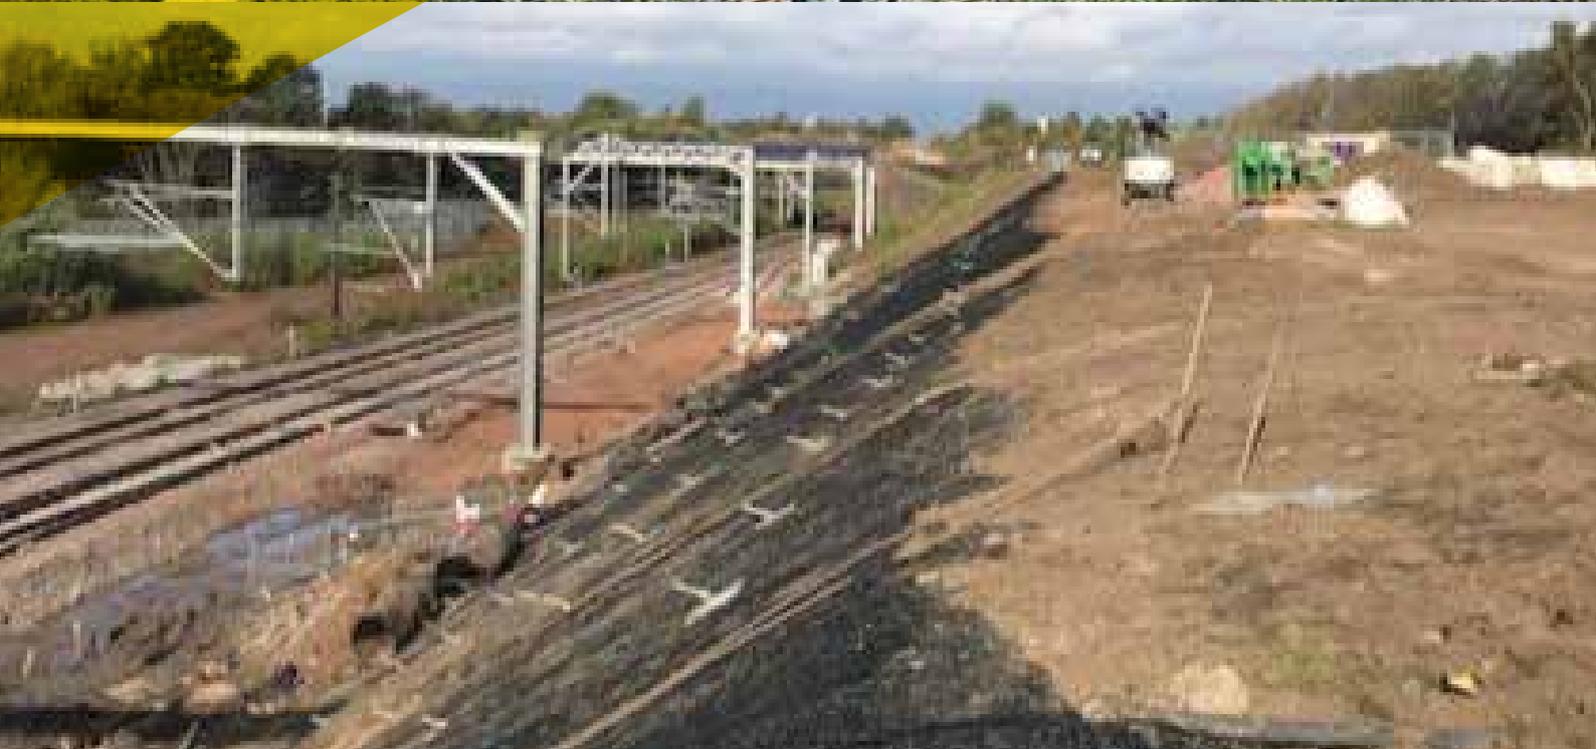
MILLERHILL SLOPE RETENTION (EGIP)

TRAC were appointed to plan, manage, supply and install a slope retention system, which involved excavating and re-profiling the embankment to provide toe level clearance, and the installation of 180 soil nails. The nature of the ground dictated that the embankment must be secured against potential failure at all times by a netting system.
